OPS Bulletin

Potable Water Cabinet (PWC) Amber Beacon On or Flashing July 17, 2019

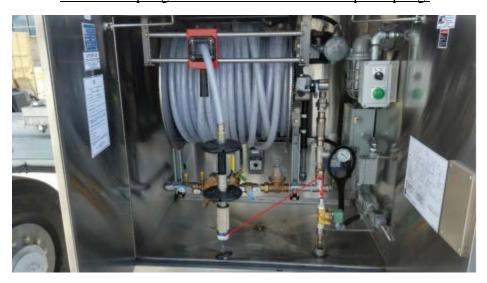
Nozzle Coupling not Connected to the Air Gap Coupling:

If the amber beacon is on, either the nozzle coupling is not connected to the air gap coupling or the nozzle ball valve is in the closed position.

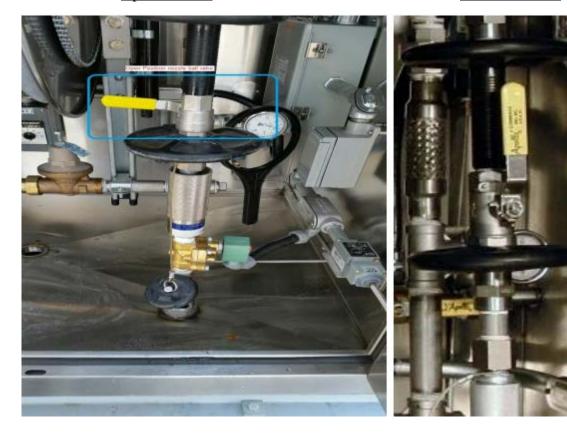
After use, ensure that the nozzle ball valve is in the open position. Keep in mind that this valve is a reverse handle valve.

Open Position

Closed Position
