# OPS BULLETIN

## TBIT BAGROOM/ULD MOVEMENT PROPERTY DAMAGE PREVENTION

No. 68  
March 24, 2017

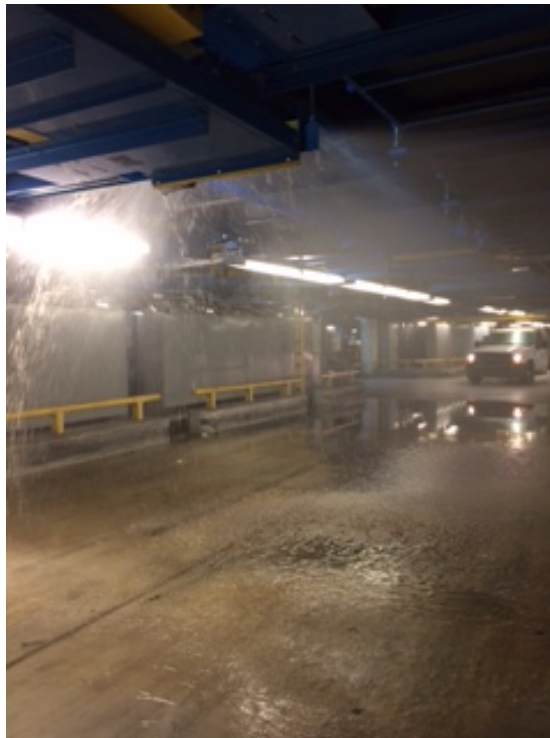
**Background:** On the evening of March 22, 2017, an Airline Service Provider damaged a fire sprinkler in the TBIT bagroom due to failure to close the ULD container door prior to reposition it.

**Root Cause:** Airline Service Provider was moving a baggage ULD with the curtain open, which came into contact with a fire sprinkler head. The sprinkler head was completely ripped off causing a flood of water in the bagroom.

**Action Required:** Airlines and Service Providers are kindly asked to immediately brief all staff regarding bagroom procedures related to the movement of ULD containers. **Prior to towing any ULD container, all curtains and doors must be fully locked in the closed position:**
